USAAVLABS TECHNICAL REPORT 71-9

**UH-1 AND AH-1 HELICOPTER MAIN ROTOR BLADE FAILURE
AND SCRAP RATE DATA ANALYSIS**

**EUSTIS DIRECTORATE
U. S. ARMY AIR MOBILITY RESEARCH AND DEVELOPMENT LABORATORY
FORT EUSTIS, VIRGINIA**

**CONTRACT DAAJ02-70-C-0016
BELL HELICOPTER COMPANY
FORT WORTH, TEXAS**

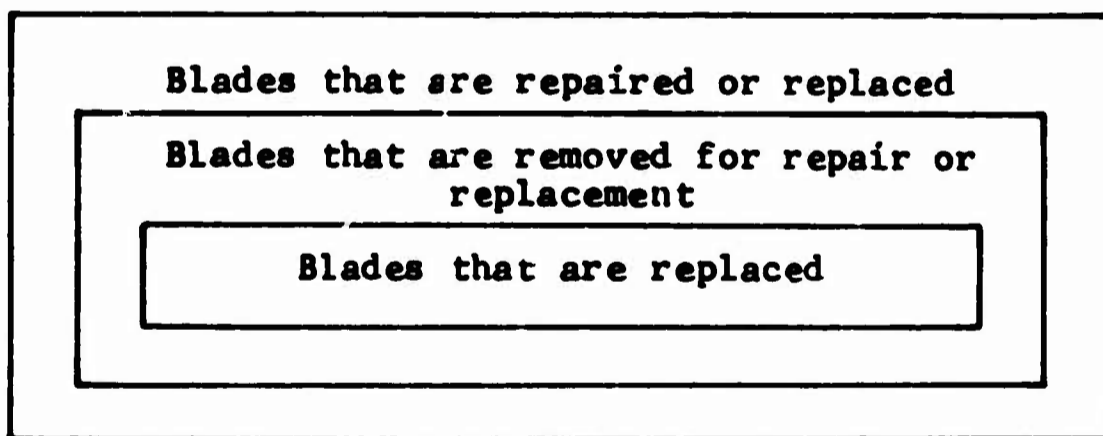
The FDR data were reviewed for the main rotor blade failures reported and those found were grouped into three sets:

- Failures that resulted in blade replacement
- Failures that resulted in blade removal for repair or replacement
- Failures that resulted in blade repair (either with blade removed or not removed) or replacement

The first set is a subset of the second which is a subset of the third as shown in Figure 1.

Figure 1. Set/Subset Relationship of the M/R Blade Failures Found in the FDR Data.
